# **Lead Local Flood Authority Flood Investigation Report**

**Flooding Incidents in various locations in the  
Borough of Stockton on Tees on 25<sup>th</sup> & 26<sup>th</sup>  
September 2012**

**Report- Draft V1**

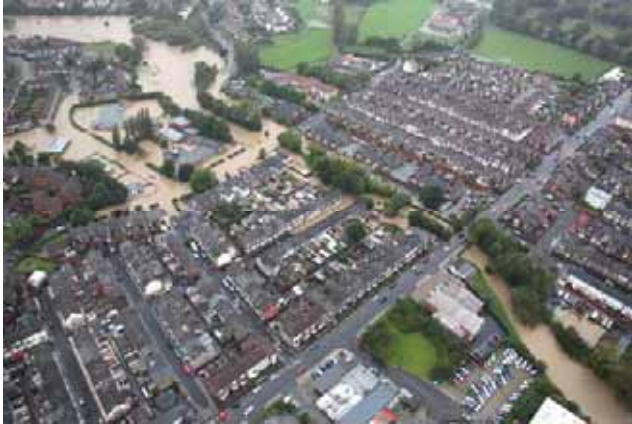
Fig 1 Photograph of Newtown Area

Figure 1 shows the extent of the flooding in Newtown and Wrensfeld, with a large number of residential properties suffering internal flooding, streets badly affected include Bishopton Road, Bedford Street, Wrensfeld Road, Dunmail Road, Duddon Walk, Tailrigg Close and Durham Road. The Bishopton Centre, Adult Education Centre, Kingdom Hall, Newtown Resource Centre and Crowe's Nest Day Nursery all suffered from internal flooding.

- It is recommended that all potential flood alleviation schemes are considered, to examine which schemes have the potential to provide the greatest benefits and whilst being affordable.
- Any current schemes in the area such as alleygates, need to be assessed to examine whether it's possible to incorporate any flood risk management measures into them.
- The surface water flooding issues needs to be fully investigated and proposals to alleviate this problem need to be considered.
- Residents should consider property protection measures as detailed above

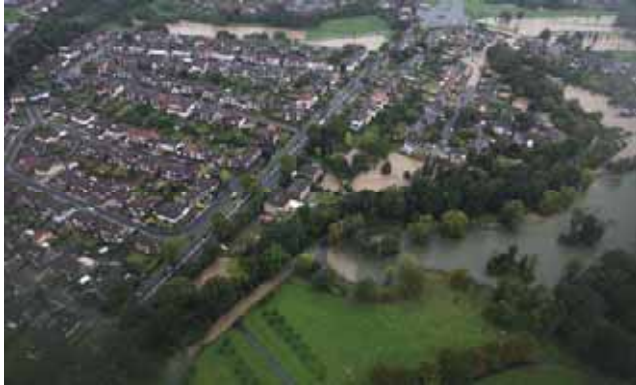
Fig 3.Hartburn Area

Figure 3 shows the extent of the flooding in the Hartburn/ Oxbridge areas, properties on Burnside Grove, Hartburn Avenue, Darlington Road and Oxbridge Lane are known to have flooded internally. Part of Ropner Park is shown to be flooded on the photograph. Figure 4 shows the entrance to Burnside Grove where a fire service rescue boat was used to evacuate residents. The grassed area adjacent to the ordinary watercourse (Greens Beck) which is a tributary of Lustrum Beck is also flooded however the flood water in that location is not thought to have entered any properties.

The area could be protected by installation of the scheme at Six Fields or smaller more localised schemes focussing on the Burnside Grove/ Oxbridge and Darlington Lane areas, however feasibility would be subject to discussions with the Environment Agency.

- It is recommended that all potential flood alleviation schemes are considered, to examine which schemes have the potential to provide the greatest benefits and whilst being affordable.
- The residents of Hartburn Avenue who already have flood defences in place and have ownership of the sump pump, must review the maintenance and operation of that pump, they should also have a plan in place for its operation in a flood situation.
- Residents should consider property protection measures.

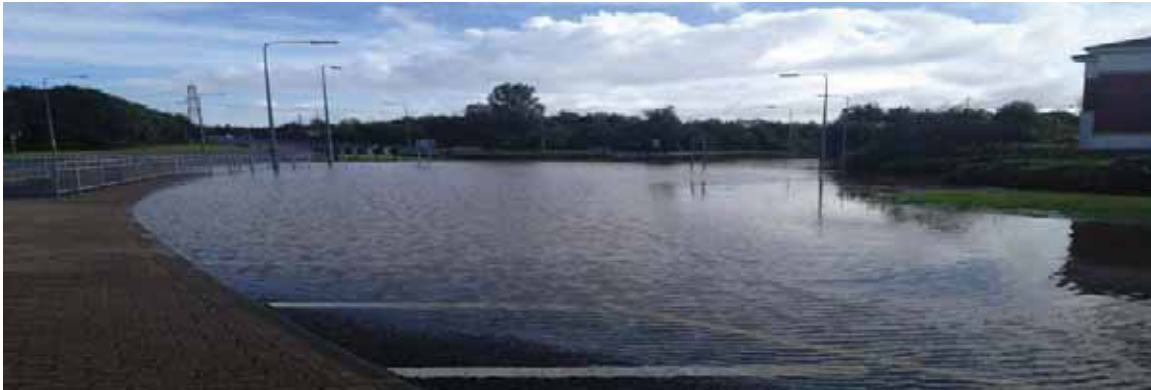
Fig 5. Billingham Road/A139

Figure 5 shows the A139 Billingham Road roundabout junction with the A19 exit slip road. The flooding in this location started on the 26th September 2012, later than the other flooding incidents connected to Lustrum Beck. The A19 exit slip began to suffer from surface water flooding due to the drainage system surcharging and being unable to discharge into Billingham Beck due to the high river levels. The gully on the roundabout also began surcharging and started to form a puddle on the carriageway which grew in size until the carriageway was impassable.

The levels in Billingham Beck continued to rise overtopping onto flood plain land where the allotments and Billingham Beck Country Park are situated. The high river levels in Billingham Beck caused the ordinary watercourses to become tide locked, preventing discharge into Billingham Beck, causing severe flooding to the network of ordinary watercourses and drainage system.

A series of meetings have taken place with other risk management partners to examine the causes of the flooding and how the risk can be reduced. At the time of writing this report, it is still very much an on going investigation and actions to be carried out are listed later in this document.

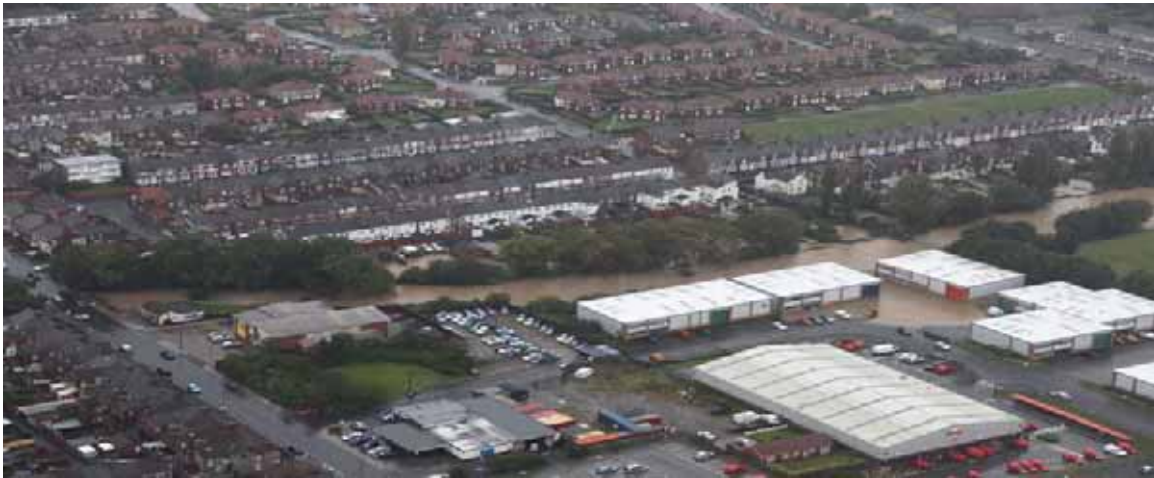
Fig 6. Business Units Orde Wingate Way

Figure 6 shows the business units located at Orde Wingate Way, Lustrum Beck is shown in the centre of the photograph, behind the business units and in front of the residential properties on Dundas Street. The photograph clearly shows the 2 buildings which are situated closest to Lustrum Beck and at the lowest level, completely surrounded by the flood water from the Beck. The gardens of the properties on Dundas Street are also flooded, the flood water is not thought to have entered any of the residential properties. The allotments were also flooded.

The source of flooding in this location is fluvial flooding directly from the beck overflowing. The area could be better protected by installation of the scheme at Six Fields or a more localised scheme, as Lustrum Beck is a main river, any such schemes would need to be either carried out by the Environment Agency or with the Environment Agencies consent. The businesses could also consider property protection measures.

- It is recommended that all potential flood alleviation schemes are considered, to examine which schemes have the potential to provide the greatest benefits and whilst being affordable.
- Businesses should investigate property protection measures

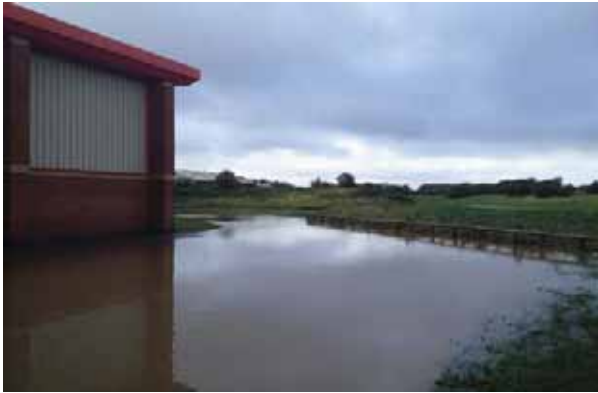
Fig 7. Business Units on Portrack Retail Park

Lustrum Beck runs to the rear of Portrack Retail Park, the park itself is split into blocks of retail units and associated car parking. Figure 7 shows flooding to one of the retail units on Portrack Retail Park in total 3 Retail units were badly affected by the flooding, Betta Living, Race for Furniture and Home Interiors causing severe damage to the premises and temporary closure of the businesses. Holme House Road was also flooded and was impassable to most vehicles, Holme House Road is the main access to and from Holme House prison.

The flooding was fluvial flooding caused by the overtopping of Lustrum Beck to the rear of the retail units.

The area could be better protected by installation of the scheme at Six Fields or a more localised scheme may be considered, as Lustrum Beck is a main river, any such schemes would need to be either carried out by the Environment Agency or with the Environment Agencies consent. The businesses could also consider property protection measures.

- It is recommended that all potential flood alleviation schemes are considered, to examine which schemes have the potential to provide the greatest benefits and whilst being affordable.
- Businesses should investigate property protection measures

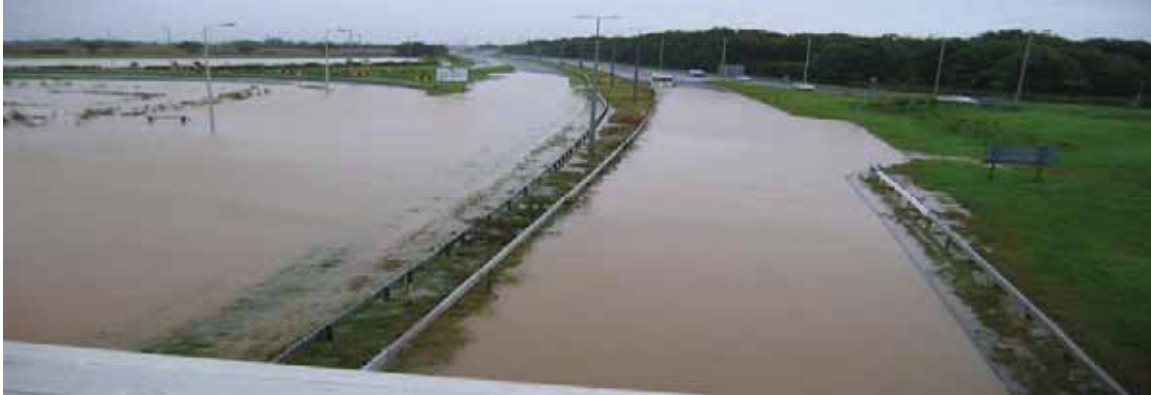
Fig 9. A66/Long Newton

Figure 9 shows the A66 at Long Newton Interchange closed in both directions due to flooding. The road has been closed on 3 occasions in the last 3 months, 25<sup>th</sup>/ 26<sup>th</sup> September 2012, 12<sup>th</sup> October 2012 and 26<sup>th</sup>/ 27<sup>th</sup> November 2012, due to the same flooding issues. The A66 is a Trunk Road forming part of the strategic highway and was closed for some considerable time on each occasion, leading to widespread disruption to travel.

It appears that the flood water has entered the carriageway from the highway drainage system and specifically overtopping of the balancing ponds which are part of this surface water system. Possible causes may be lack of capacity in the ponds or the associated drainage network, maintenance issues in the surrounding network, run-off from farmland or illegal connections into the system. A full investigation of the drainage system and site is required before a definite source can be identified.

8.1		The businesses can consider property protection measures.	Businesses	-
9.0	A66 Long Newton Interchange	Highways Agency is investigating the causes into the flooding and the performance of their drainage system, CCTV survey will also be carried out.	HA	6months
